# NASA/TM-2002-211577

# Issues and Consequences of Atomic Oxygen Undercutting of Protected Polymers in Low Earth Orbit

Bruce A. Banks, Aaron Snyder, and Sharon K. Miller Glenn Research Center, Cleveland, Ohio

Prepared for the Sixth International Conference on Protection of Materials and Structures from Space Environment cosponsored by ITL, UTIAS, MMO, AFOSR/NL, CRESTech, EMS Technologies, and MDRobotics Toronto, Canada, May 1–3, 2002

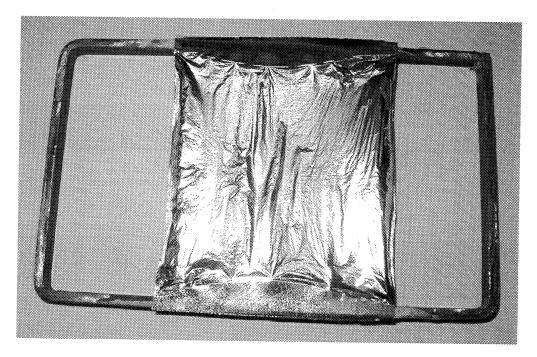
Figure 4.—Photograph of a vacuum deposited aluminized Kapton® sample bonded to a metal frame after ground laboratory oxidation of the Kapton®.

As can be seen in Figure 4, where the  $\sim 1000$  Angstrom aluminum film in the lower portion of the sample is free standing, stress wrinkles and tears develop similar to those seen in the ISS photograph of Figure 3.

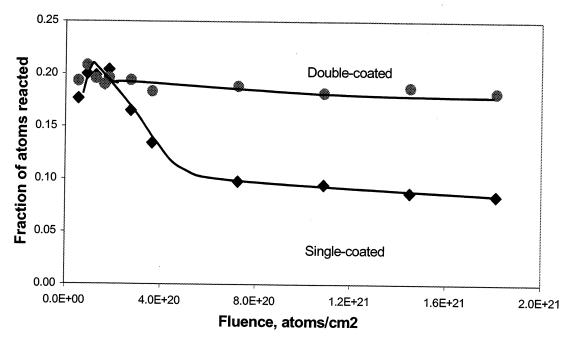
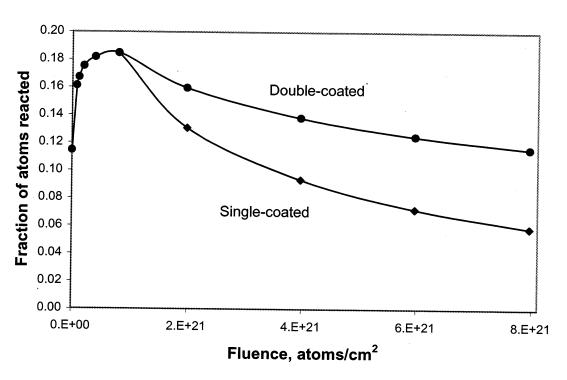
Figure 6.—Computational atomic oxygen erosion predictions for 45-degree incident atomic oxygen attack at defect sites protected Kapton®.

As can be seen in Figure 6, for both 2-dimensional modeling of a crack or scratch defect and 3-dimensional modeling of a circular defect the growth characteristics of the under cut cavity have similar trends with fluence. Initially, as the undercutting starts the existence or absence of the back surface coating plays no role and as the cavity grows the probability of atoms reacting increases due to trapping of the incoming atom. However, as the bottom surface is reached, atoms begin either to escape, or in the case of no back-surface coating, they recombine after collision with the SiO<sub>2</sub> on the back surface. The double surface aluminized Kapton® consistently reacts more atomic oxygen atoms than the single surface aluminized Kapton® except at very low fluences where the erosion in either case does not reach the bottom of the polymer. For both cases, as the fluence increases, the atomic oxygen can escape out the bottom (only in the case of the single surface aluminized Kapton®), recombine, or thermally accommodate and thus becomes less probable to react with the Kapton®. Thus it appears that a single surface aluminized Kapton® would have been much more durable because the unreacted atoms passing through the bottom of the polymer would simply enter into the open pore foam and gradually react with it, without causing much damage to the aluminized Kapton®.

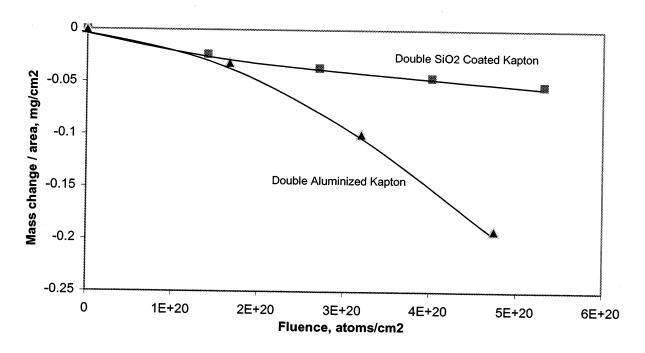
The double- $SiO_2$  coated ISS solar array blankets may show similar detachment of the outer surface  $SiO_2$  layer with time. However, the defect density appears to be much lower than for vacuum deposited aluminum coatings as shown in Figure 7 which compares the experimental results of RF plasma oxidation of double aluminized Kapton® with double  $SiO_2$  coated Kapton®.

Figure 7.—Comparison of RF plasma oxidation of aluminized and SiO<sub>2</sub> coated Kapton®.
